Audit of Ambient Air Monitoring Stations for the Sistema de Monitoreo Atmosférico de la Ciudad de México

Eric Anderson
EPA Systems, LLC
Austin, Texas

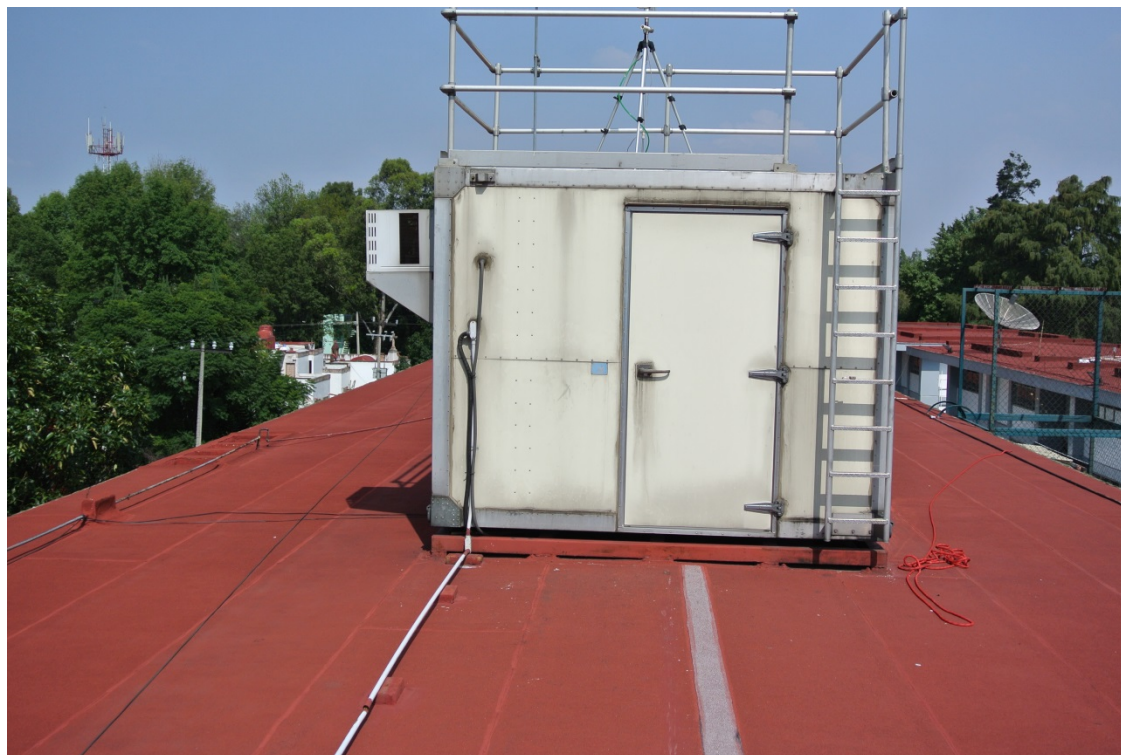
Figure 3-3. Front View of COY Site Shelter

This station is located on the fourth floor roof of an elementary school in a residential area in southwest Mexico City. The system is housed in an EKTO shelter. The shelter was in excellent condition. This site was only equipped with an API NO_x and O₃ gas analyzers and a TEOM 1400A with 8500 FDMS PM_{2.5} particulate matter analyzer. There were no met sensors at this site. The audit results showed that all of the parameters {O₃ (2.4%), NO (-1.4%), NO_x (-0.3%)} were well within the audit objective of $\pm 15\%$. In addition, the GPT showed a NO₂ convertor efficiency of 102.4%. Audit results for each of the analyzers at this site are shown in Tables 3-7 to 3-10.

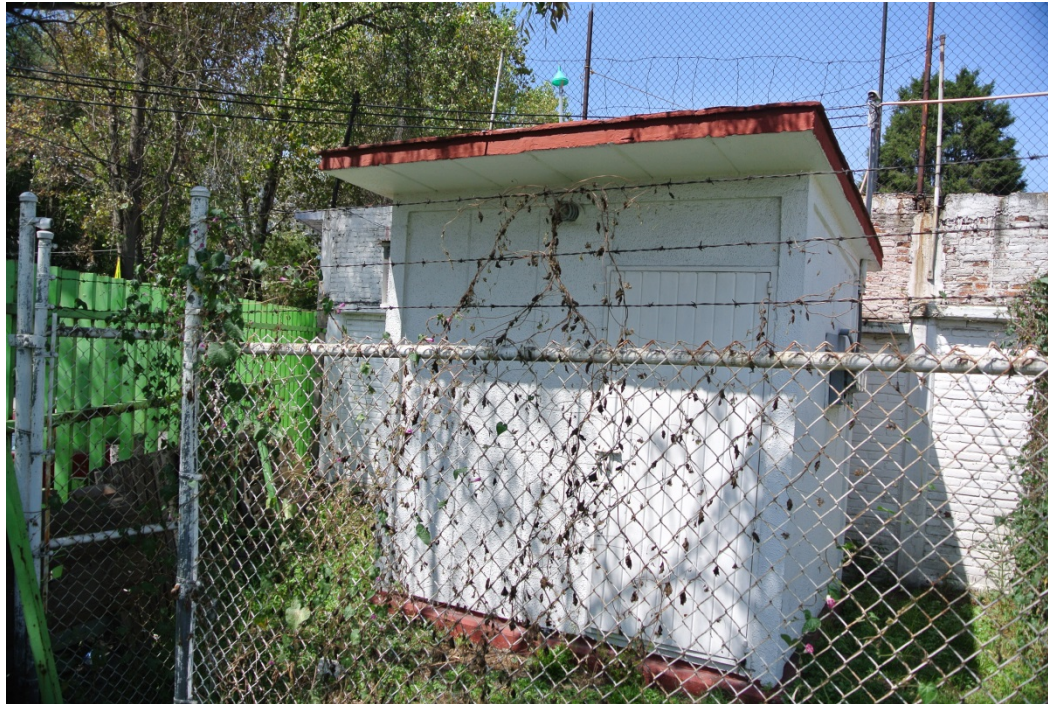
Figure 3-13. LPR Site Front View

The LPR site is located on the grounds of a local small hospital/clinic. The site is situated in and are that abuts a large mountain range. This siting makes getting perfect sampling locations difficult due to the very steep rise in elevation around the site. While the site is not ideal from an exposure perspective, its' exposure is adequate to represent the ambient conditions in this mostly residential areas. The audit results showed that all of the parameters {O₃ (-3.0%), NO (-2.39%), NO_x (-1.6%), and SO₂ (1.6%)} were well within the audit objective of $\pm 15\%$. The GPT showed a NO₂ convertor efficiency of 100.3%. Sample results for each of the analyzers at this site are shown in Tables 3-53 to 3-57. Photos of this site are shown in Figures 3-13 and 3-14 below.
